**REPORT-2025-30**

CUSTOMER: Vinyylitalo Oy / Jukka Toivola

ASSIGNMENT: Vinyylitalo's Barrier Structure Strength Tests

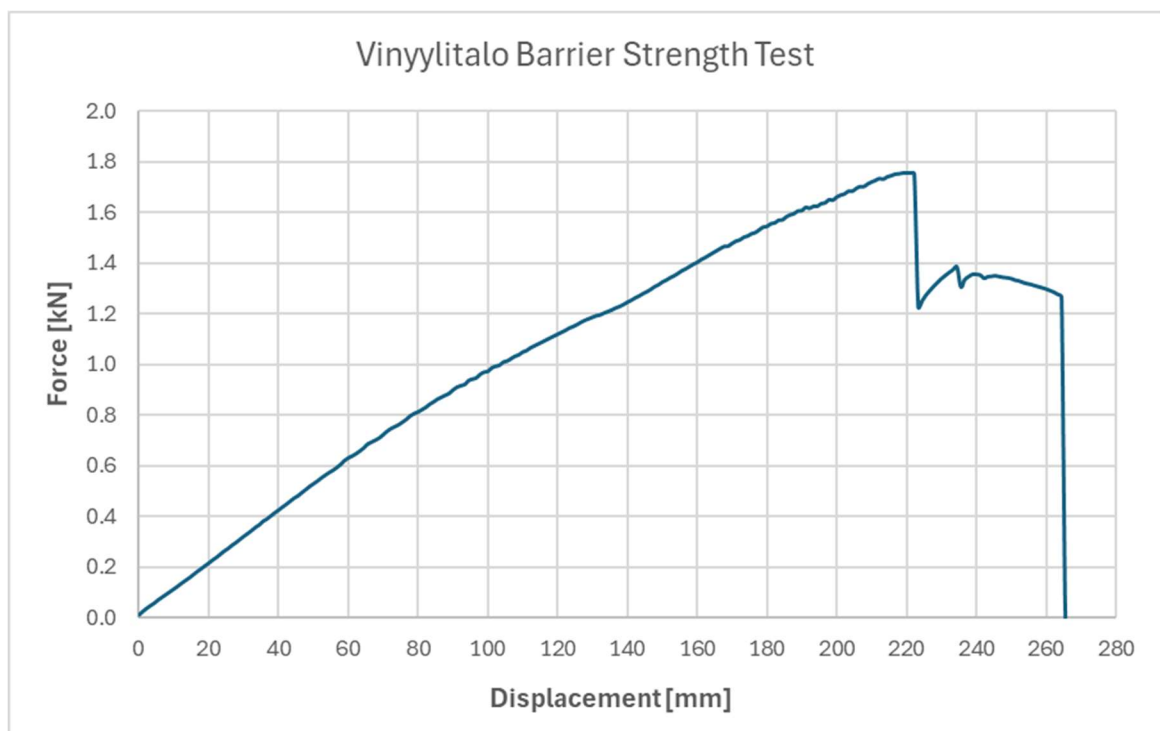
| Test name | Loading speed [mm/min] | Ultimate force [kN] | Corresponding displacement [mm] |
|---|---|---|---|
| Test 1 | 200 | 1.75 | 218.85 |

Figure 4. Force versus displacement curve of the test.

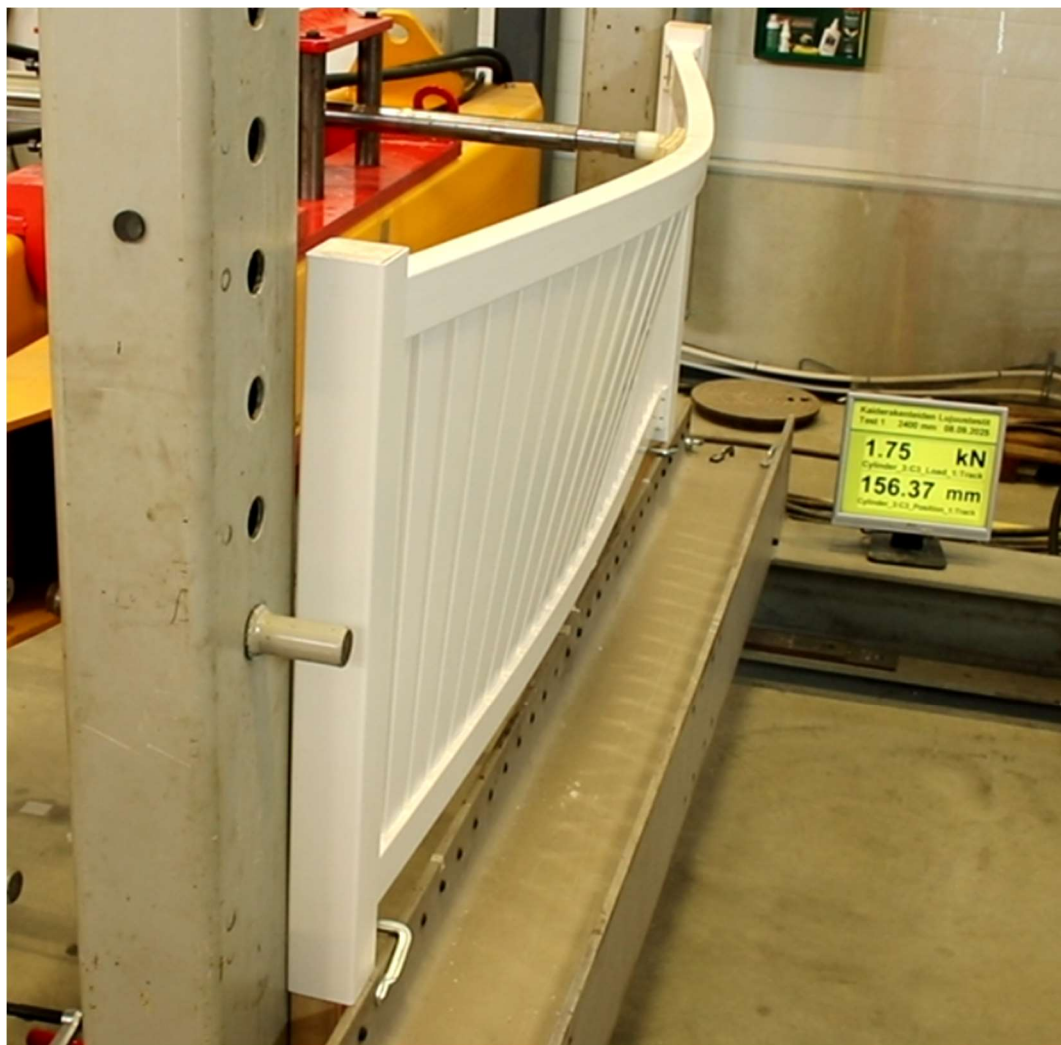
The failure mode was bending of the upper rail and consequent snapping out of its side holder. The photographs of the tested structure under load and the failure mode are presented in Figures 5 to 7.

Figure 5. The barrier structure under load and bending of the upper rail.

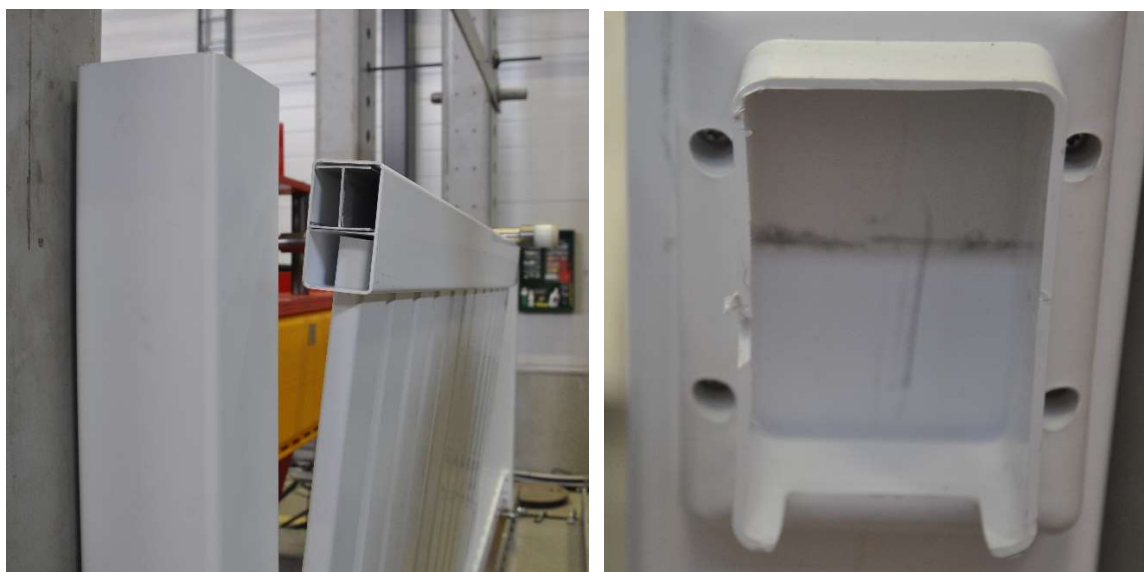
Figure 6. Test 1 barrier structure failure.

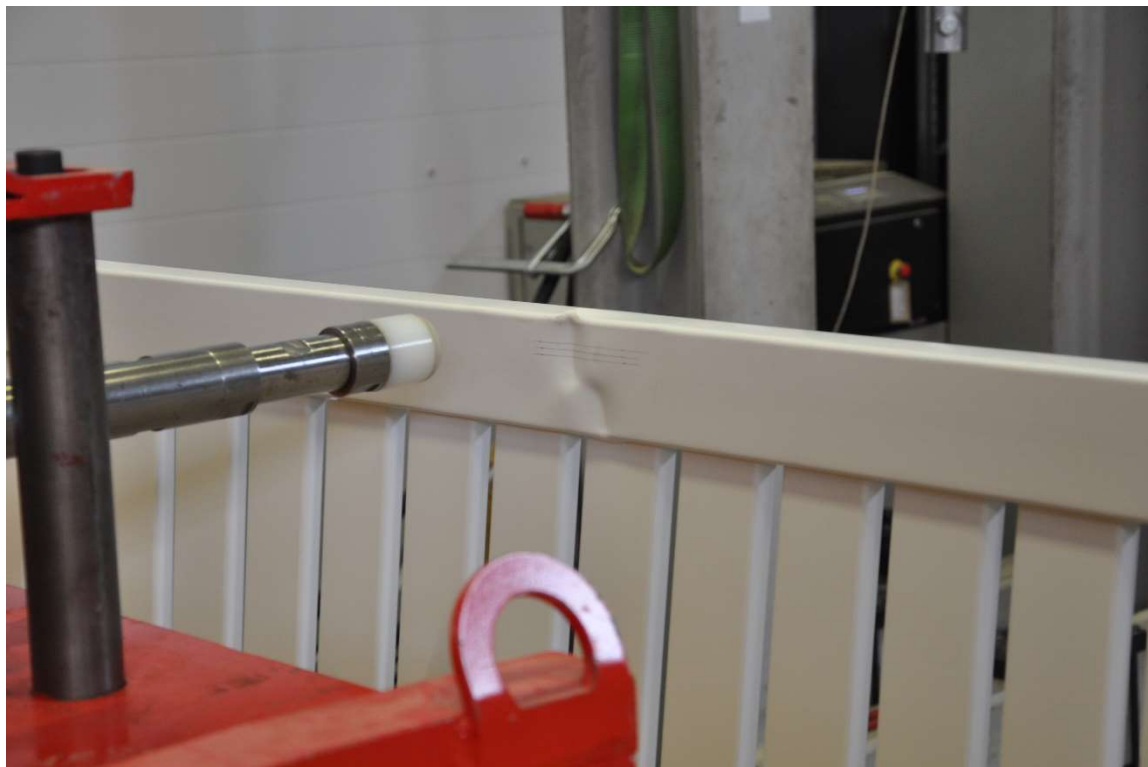
Figure 7. Upper rail damage.
