**REPORT-2025-27**

CUSTOMER: Vinyylitalo Oy / Jukka Toivola

ASSIGNMENT: Vinyylitalo's Barrier Structure Strength Tests

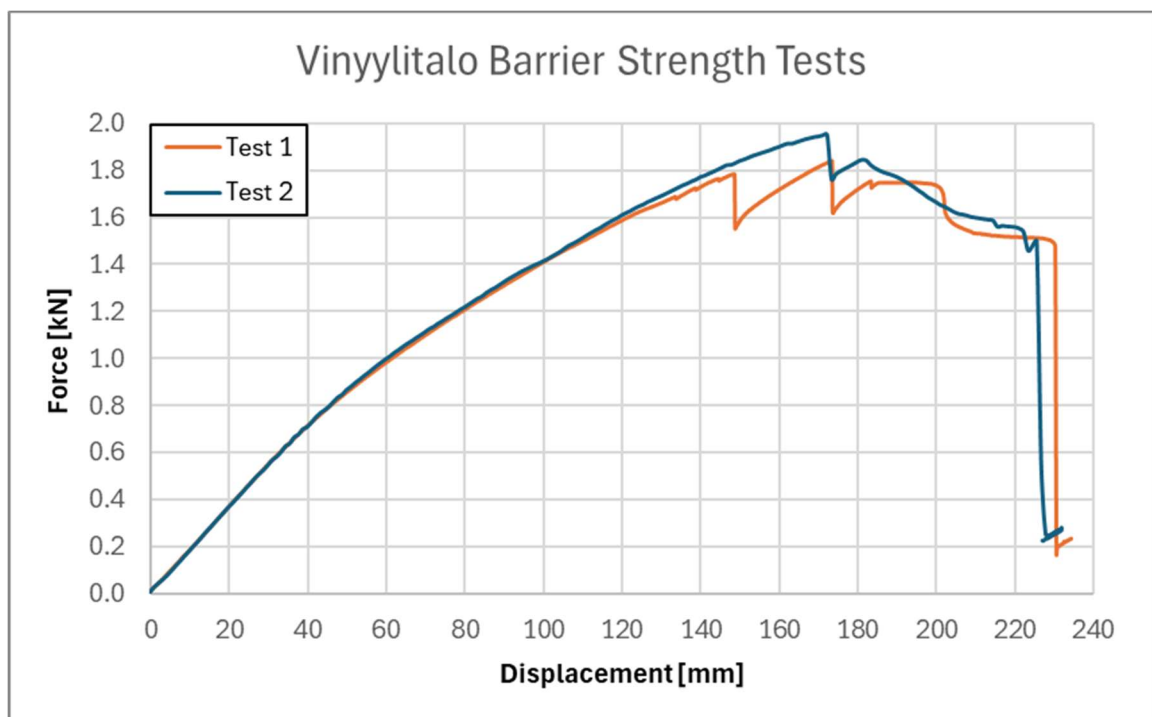
The summary of the test results is listed in Table 1. The result summary presents the loading speed, ultimate force achieved during the test and its corresponding displacement. The force versus displacement curves for each test are shown in Figure 4.

Figure 4. Force versus displacement curves of the tests.

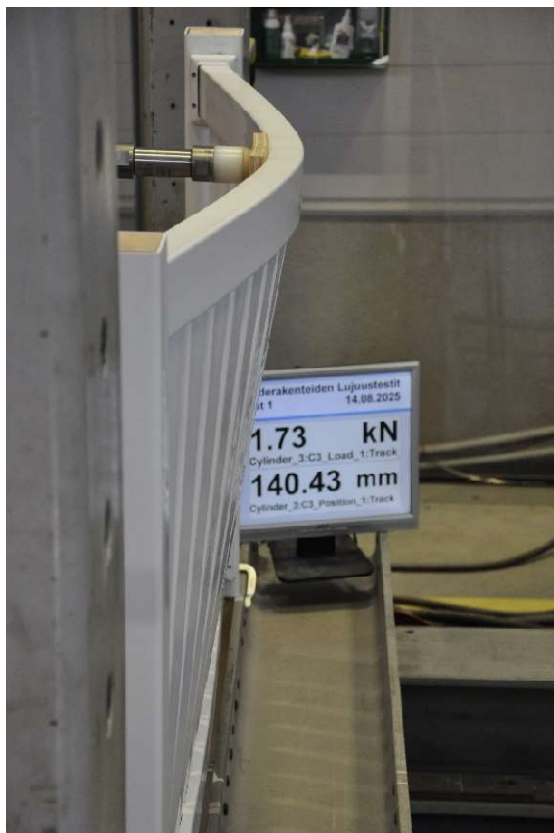
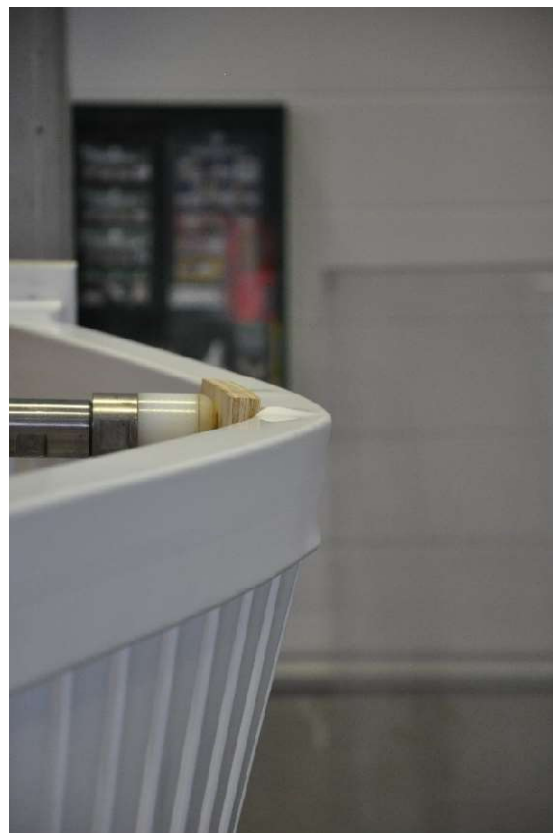
The failures in both tests were bending of the upper rail and consequent snapping out of its side plastic holders. The photographs of the tested structure under load and their failure modes are presented in Figures 5 to 9.

Figure 5. The barrier structure under load and bending of the upper rail during Test 1.

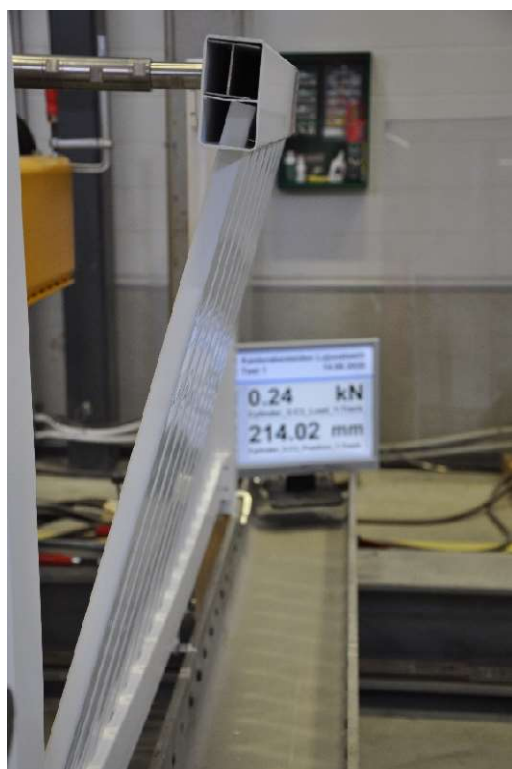
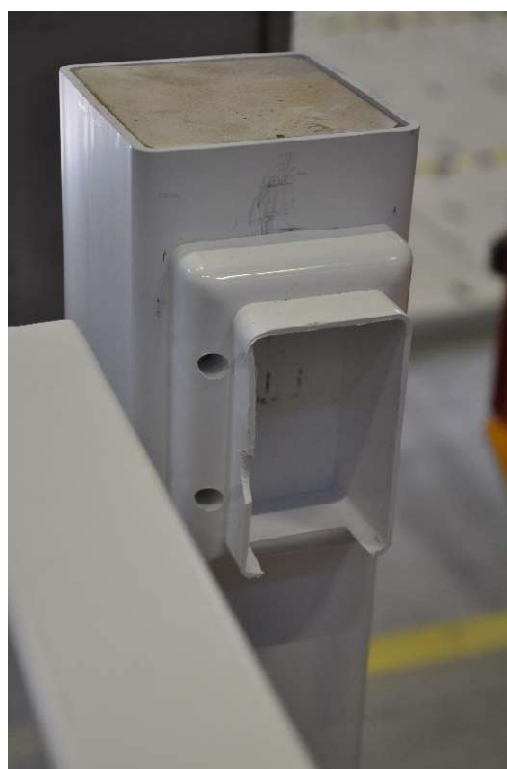
Figure 6. Test 1 barrier structure failure.

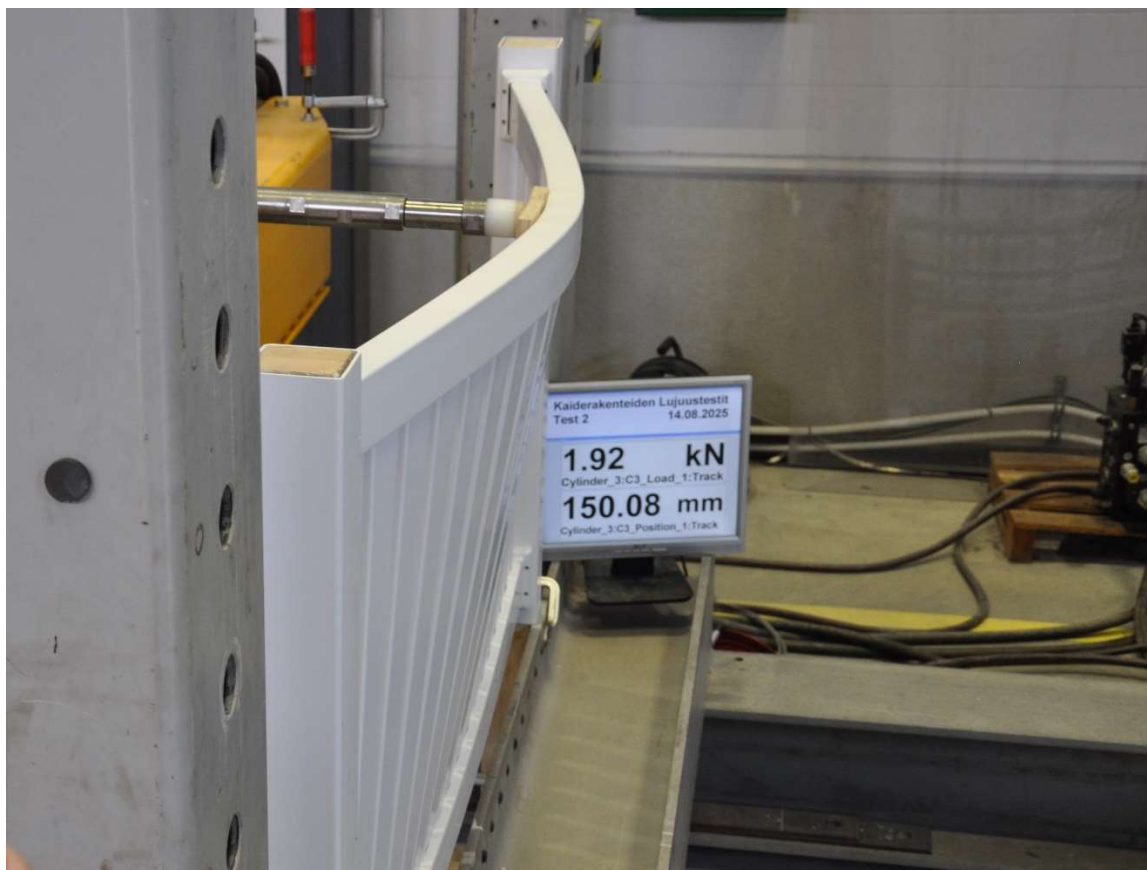
Figure 7. The barrier structure under load during Test 2.

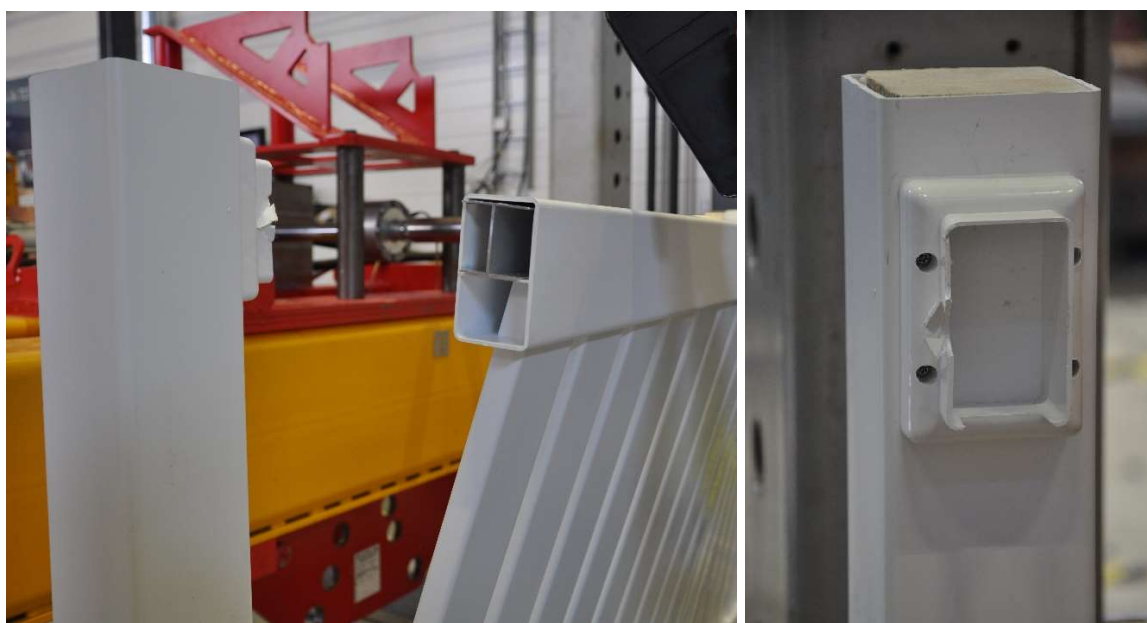
Figure 8. Test 2 barrier structure failure.

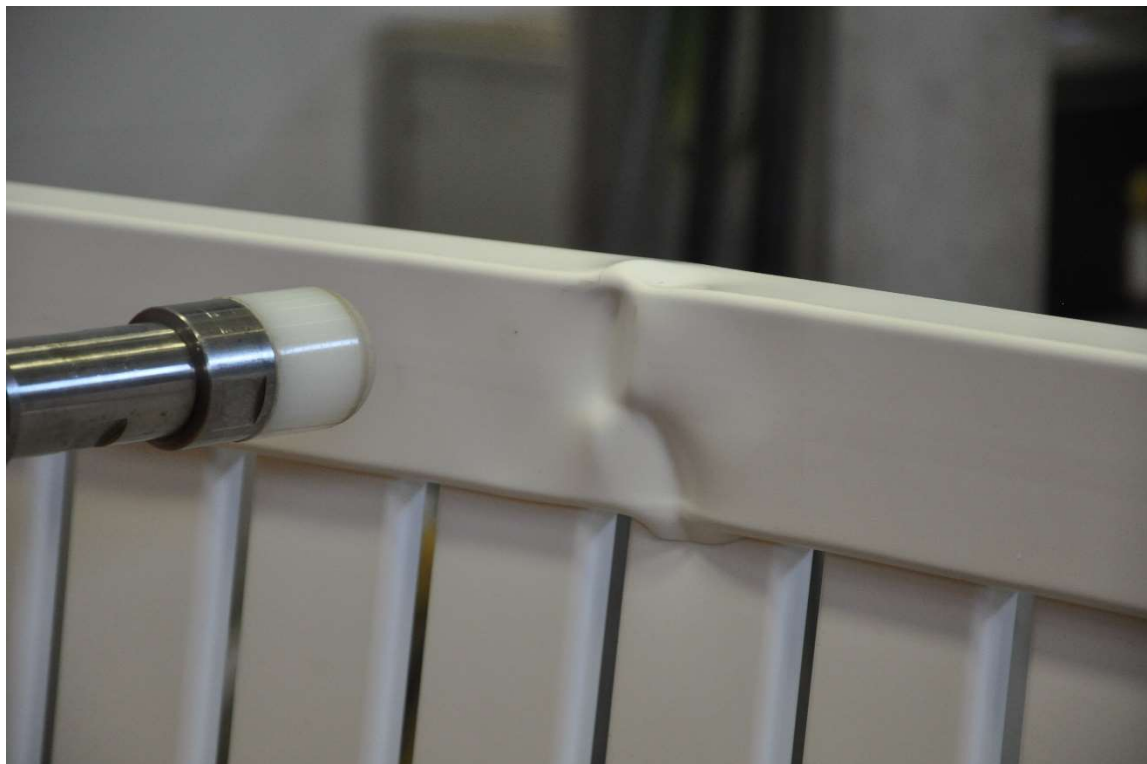
Figure 9. Test 2 upper rail damage.
